DCC Guidance Note

Use of DUIS

Document Version: V2.13

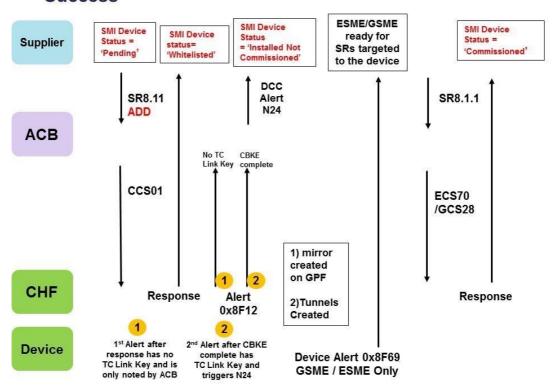
Figure 1. Establishing the HAN - Success

Service Request 8.11 UpdateHANDeviceLog with a Request Type of "Add" is sent to the CHF to add the device to the Device Log (i.e. to Whitelist the device) and to allow a connection to be established between the CHF and the requested device on the ZigBee HAN. As part of this process, the CHF sends two Alerts with code 0x8F12 to the Access Control Broker (ACB = DSP) remote Party.

- The first Alert confirms the addition of the requested device to the Device Log and is simply noted by the ACB.
- The second Alert confirms completion of the exchange of Link Keys (Certificate Based Key Exchange) between the CHF and the requested device. The ACB informs the User of this event by sending DCC Alert N24 Successful Communications Hub Function Whitelist Update.

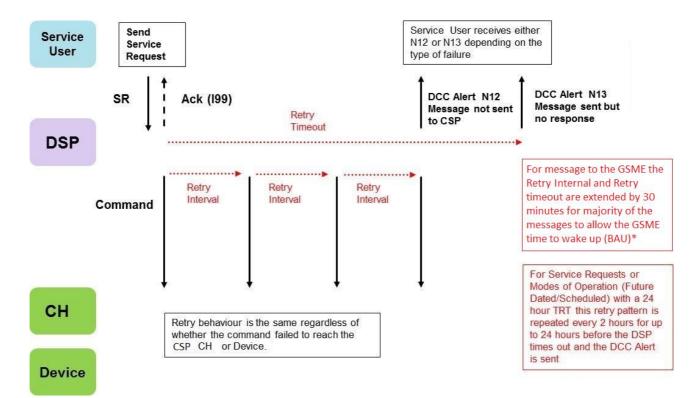
The overall approach for retry and timeout for processing of a Service Request being sent to a device is summarised in the diagram below.

Figure 4. Retry and Timeout Processing of a Service Request

When a User sends a Service Request and receives a successful Acknowledgement (I99) the DSP solution starts a number of timers to handle retry behaviour for the processing of that Request:

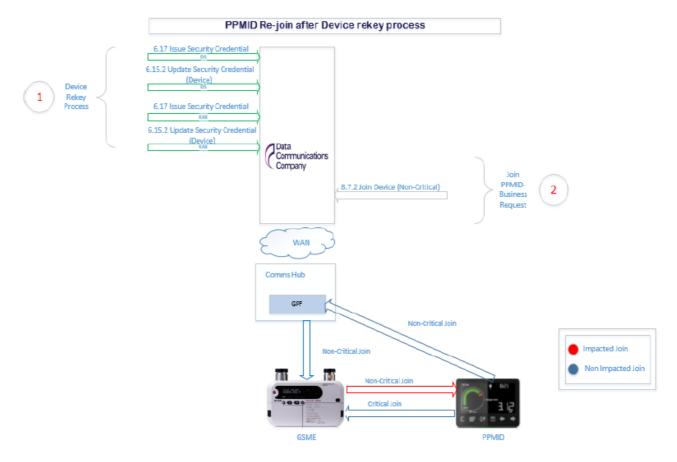
Figure 1: Schematic showing sequence required
